Engineering Field Trip Report

Fine Gold Reservoir

Study Team Field Trip Report (June 12, 2002)

Upper San Joaquin River Storage Investigation Field Trip Logs

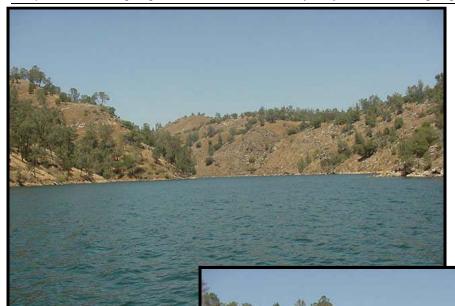
<u>Fine Gold</u> - Upstream view of Fine Gold Creek.

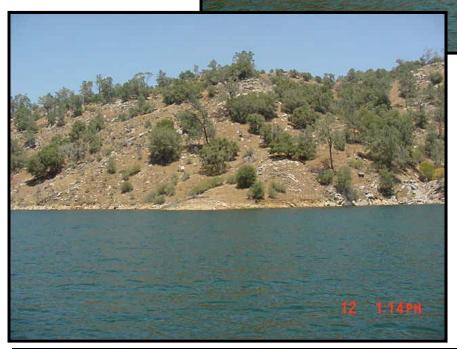
Cross stream view of proposed left abutment.

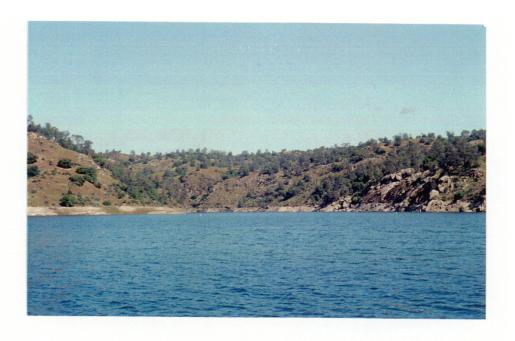
Photo 19

View upstream (north) of the Fine Gold Creek arm of Millerton Lake. Hidden Lake Estates is located immediately to the left of the photo. The damsite is located farther upstream where the abutments reach an elevation of El. 1100.

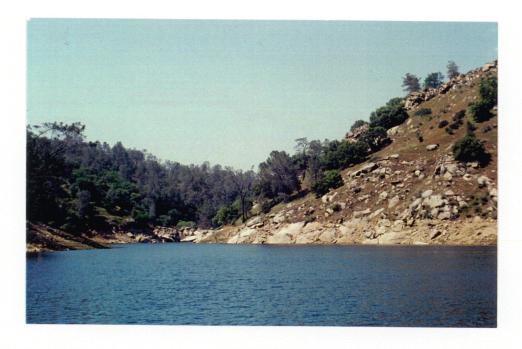
Photo 20

View upstream (north) of the damsite. Outcrops and shoreline exposures are mostly hard, fresh granitic rock.

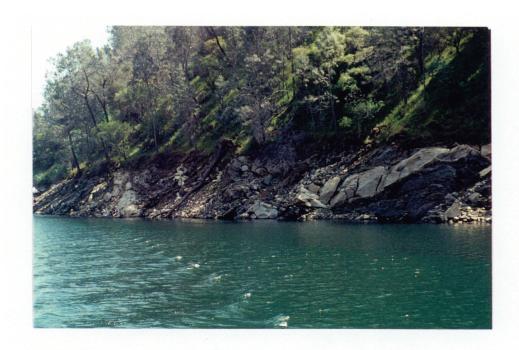
Photo 21

View downstream (south) of the shoreline downstream of the right (west) abutment. The water-scoured shoreline exposes dark gray metamorphic rock intruded by white granitic dikes.

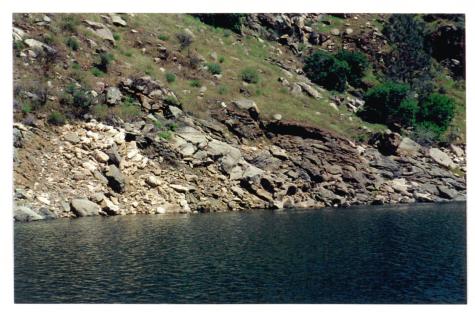
Photo 22

View downstream (southwest) of the shoreline downstream of the left (east) abutment. The water-scoured shoreline exposes gray to brown metamorphic rock intruded by white granitic dikes.

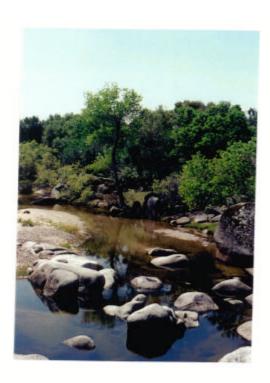
Photo 24

View downstream (south) of Fine Gold Creek from the Road 210 bridge located 1 mile west of Hildreth near the northern limit of the reservoir. The creek bottom exposes scoured granitic boulders and inplace rock. The water level in June 2002 was at least 2 feet lower than the April 2001 water level. A noticeable algae bloom was present in June 2002.

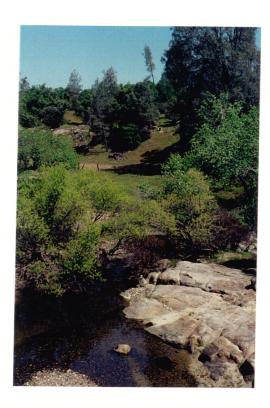
Photo 25

View upstream (north of Fine Gold Creek from the Road 210 bridge. The creek bottom exposes scoured granitic rock. Granitic outcrops that are typical of the entire reservoir area are visible in the background.

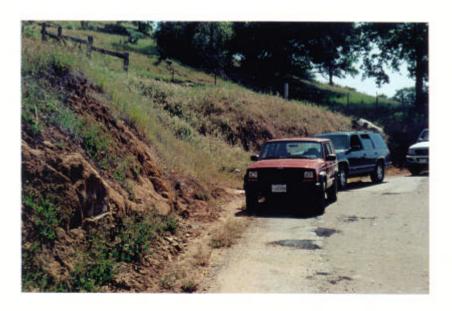
Photo 26

View to the east of a roadcut located about ½ mile northwest of Hildreth on the lower slopes of Hildreth Mtn. near the western margin of the reservoir. The roadcut exposes intensely weathered and decomposed granitic rock and a few hard, fresh corestones – a typical granitic weathering profile that is observed throughout the reservoir area.

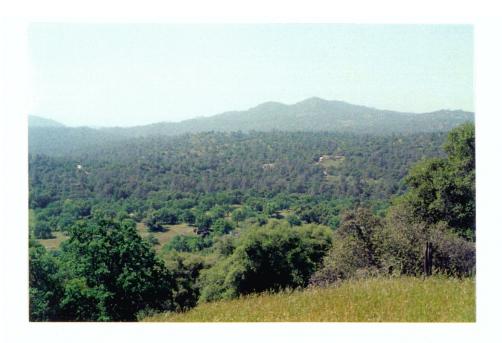
Photo 27

Panoramic view to the southwest of the reservoir area. The highest peak in the background is Hulbert Mtn. (El.).

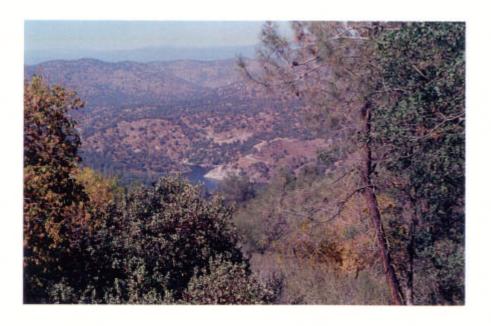
Photo 28

Panoramic view to the northeast of the San Joaquin River canyon from the road just south of Temperance Flat. Kerckhoff Powerhouse No. 1 and a waste berm are visible at photo center. The waste berm is composed of "tunnel muck" (mostly granitic rock fragments) that was produced by the excavations for the underground powerhouse and access tunnels.
